Pipeline and Hazardous Materials Safety Administration (PHMSA)

Accident Investigation Division (AID)

Western Region Gas Conference

Case Study – Stuck ILI Tool Incident

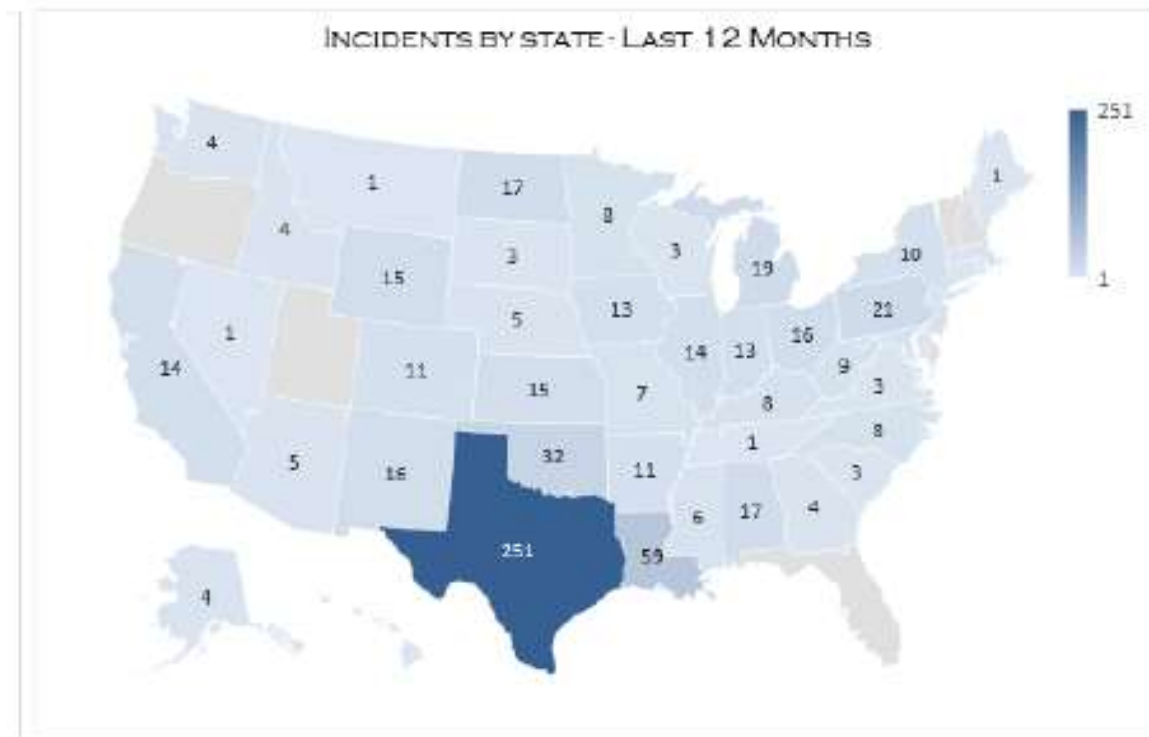
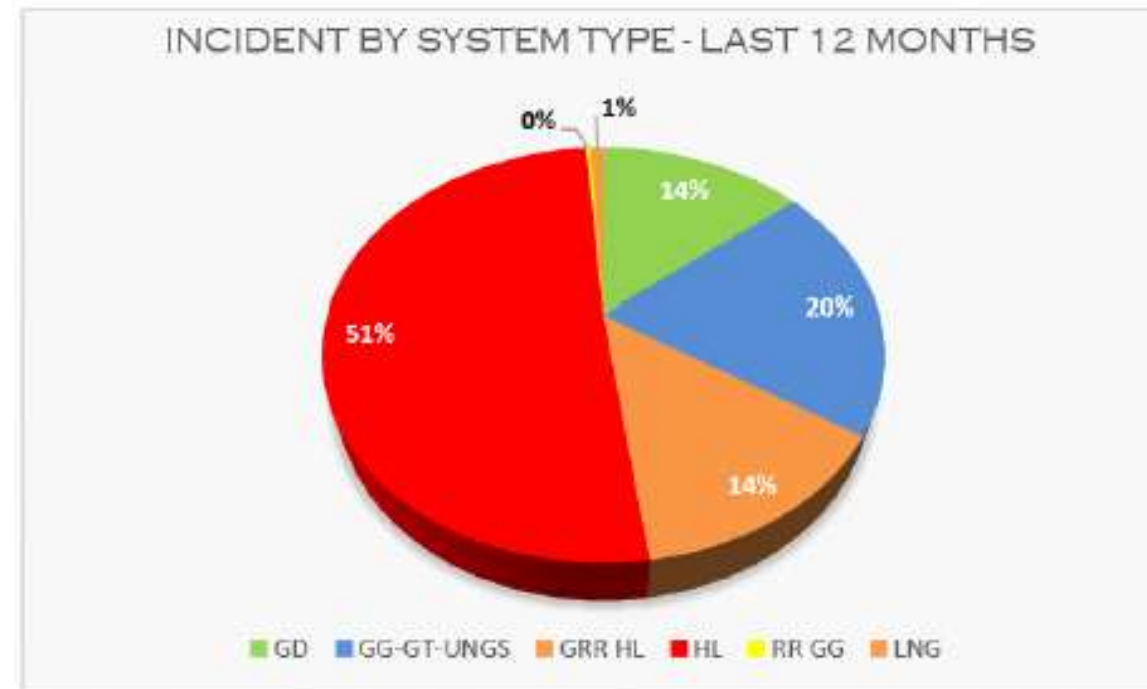
Chart based on 30-day report data for incidents that occurred 6/21 to 6/22

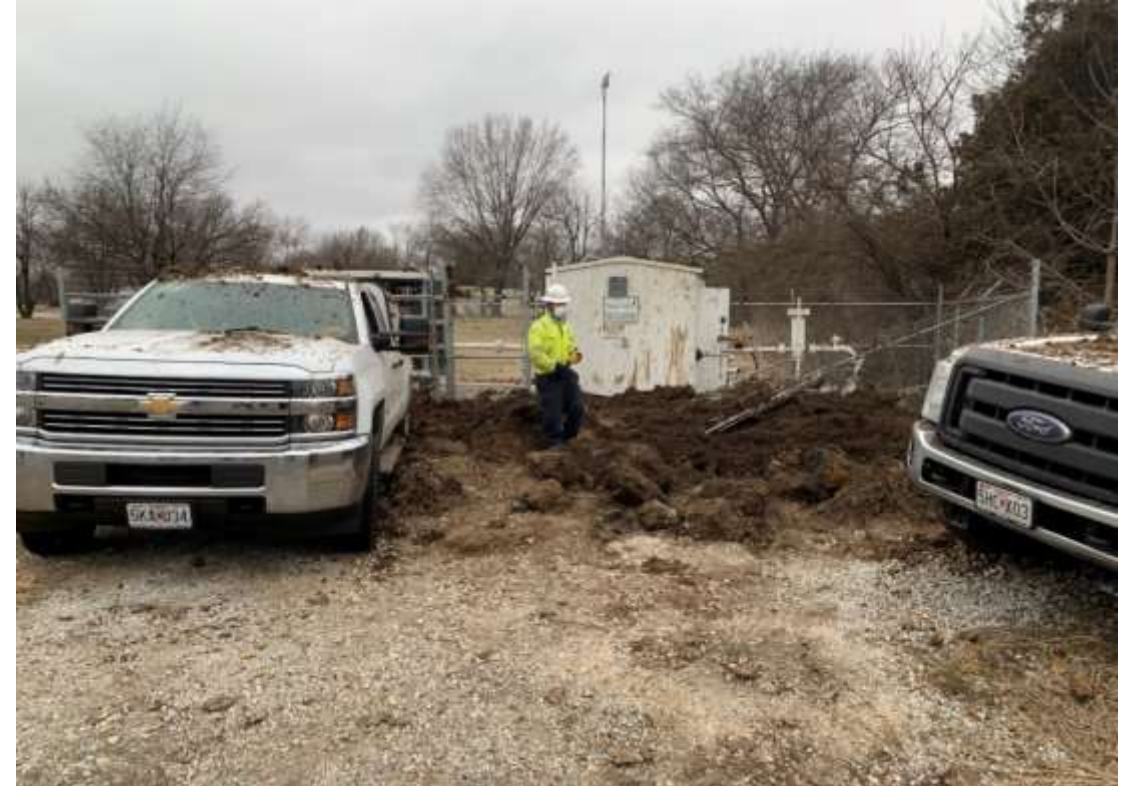
- Rupture caused by ILI tool ejecting from the pipe through an elbow bend
- Two employees injured, one hospitalized
- 76 MCF natural gas released
- Cost Approximately 800K
- Over 1000 customers impacted

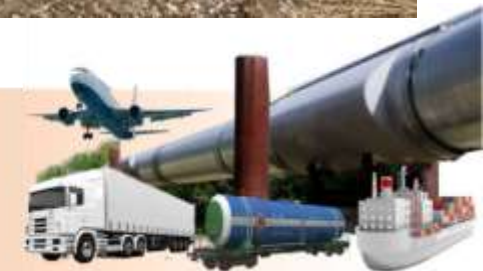
Case Study – Events Leading up to the Failure

- Operator was running the MFL-C ILI tool when it got lodged in an elbow
- They started cycling pressure to dislodge the ILI tool
- Pressure built up behind the tool and propelled it through the pipe at an elbow combination of 90°-45° fittings

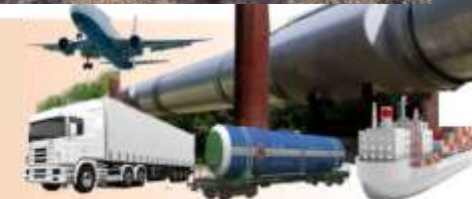
Case Study – Findings and Contributing Factors

Root cause of the failure was **incorrect operation**

- Operating parameters were not within tool specifications
- A modified tool launch sequence was implemented without required review and approval
- Attempts to dislodge the tool were not in accordance with written procedures

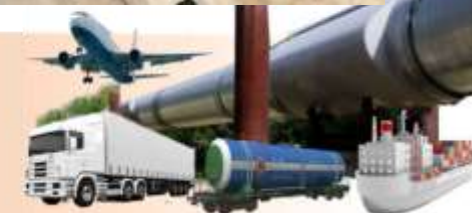
Procedural/Documentation Issues:

- ILI procedure did not specify how to dislodge a stuck tool
- OQ-AOC stated to follow a procedure that operator had not developed
- Operator had missing as-built drawings and were unaware of the specific elbow configuration, including the 90°-45° fittings

- Operator has issues with previous tool runs were not communicated to the vendor
- The replacement tool had a different configuration than the original tool specified for this system
- Operator did not launch the tools at velocities reported on the vendor questionnaire
